Manhole Inspection Summary

Manhole # S45G2_011MH

Insp Date: **1/8/08 9:54 AM**

Location Address: **1427 Locust St** Cross Street: **Fairhaven Ave.**

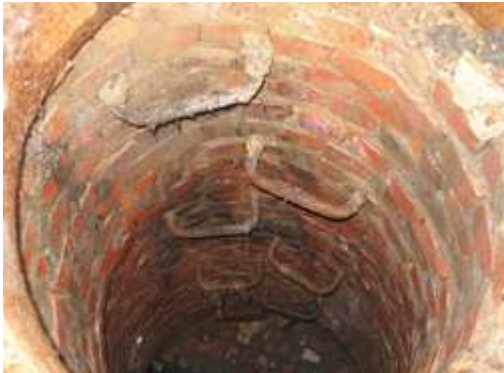
Steps Count: **7** Missing: **0** ☐ Corroded

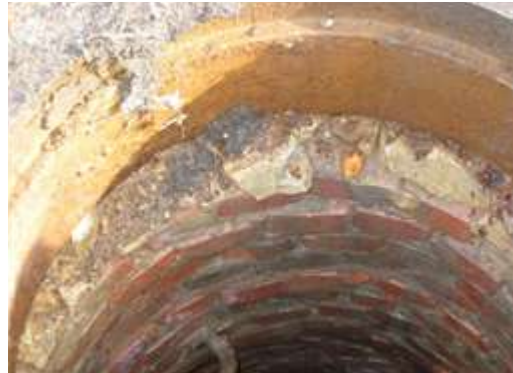
Defect 1

Frame Offset: **2** (in.) Condition: ☒ Sound ☐ Cracked ☐ Leaks

Frame offset

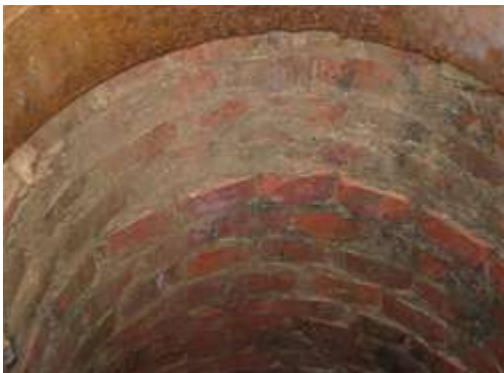
Defect 2

Corbel Material: **Brick** ☐ Parged Type: **Concentric/Eccentric**
Condition: ☒ Sound ☐ Cracked ☐ Root Intrusion ☐ Loose Brick ☐ Deteriorated
Infiltration: ☐ None ☐ Joint ☐ Cracks ☒ Mortar ☐ Roots ☒ Wall

Infiltration

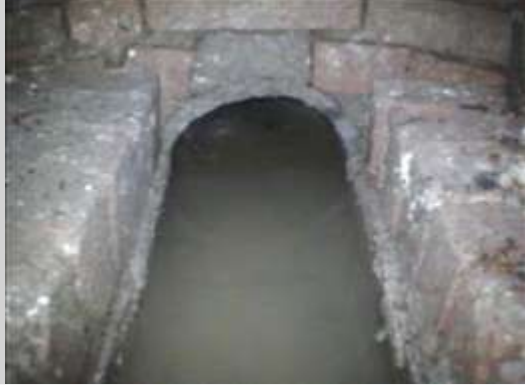
12 O'Clock Outflow

8 in. Circular Gravity Sewer
Pipe Out @ 12 O'Clock

Pipe Height: **8.4** (in.) Rod and Bar (Angled)
Pipe Material: **Clay** ☐ Pipe Lined
Invert Depth: **11.34** (ft.) Flow Characteristics: **Slow**
Deposits: ☒ None ☐ Mud ☐ Sludge ☐ Debris ☐ Grease
Silt Depth: (in.) Deposits Extent:
Infiltration: **None** Pipe Seal Cond: **Sound**

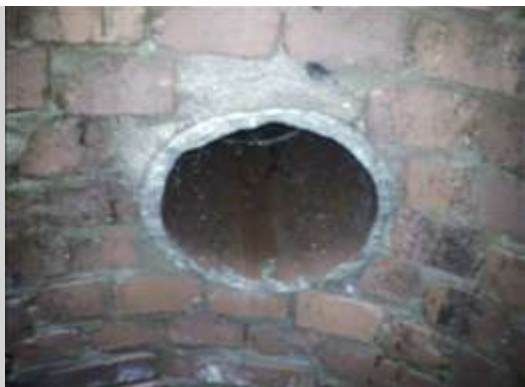
6 O'Clock Inflow

8 in. Circular Gravity Sewer
Pipe In @ 6 O'Clock

Pipe Height: **8.4** (in.) Rod and Bar (Angled)
Pipe Material: **Clay** ☐ Pipe Lined
Invert Depth: **7.67** (ft.) Flow Characteristics: **Slow**
Deposits: ☒ None ☐ Mud ☐ Sludge ☐ Debris ☐ Grease
Silt Depth: (in.) Deposits Extent:
Infiltration: **None** Pipe Seal Cond: **Sound**

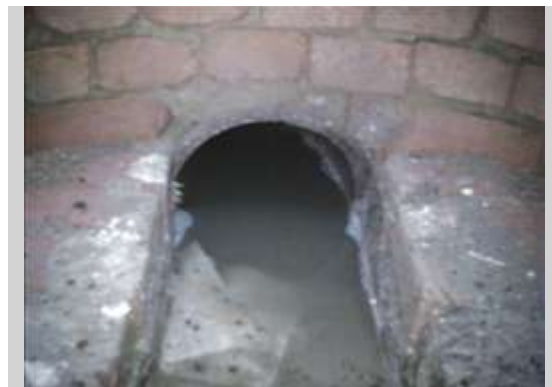
Drop In @ 6 O'Clock

Drop: **Outside** Rod and Bar
Angled: **Yes** Reading: **10.15** (ft.)
Inv Depth: **11.15** (ft.)
Drop Condition: **Open**
